A critical incident during anaesthesia in the operation theatre

In this article, we describe a critical incident which occurred in our operation theatre involving an anaesthesia machine. The oxygen flowmeter broke into three pieces and completely shut down the oxygen flow during anaesthesia. A brief review of the literature on equipment failure during anaesthesia is also given.

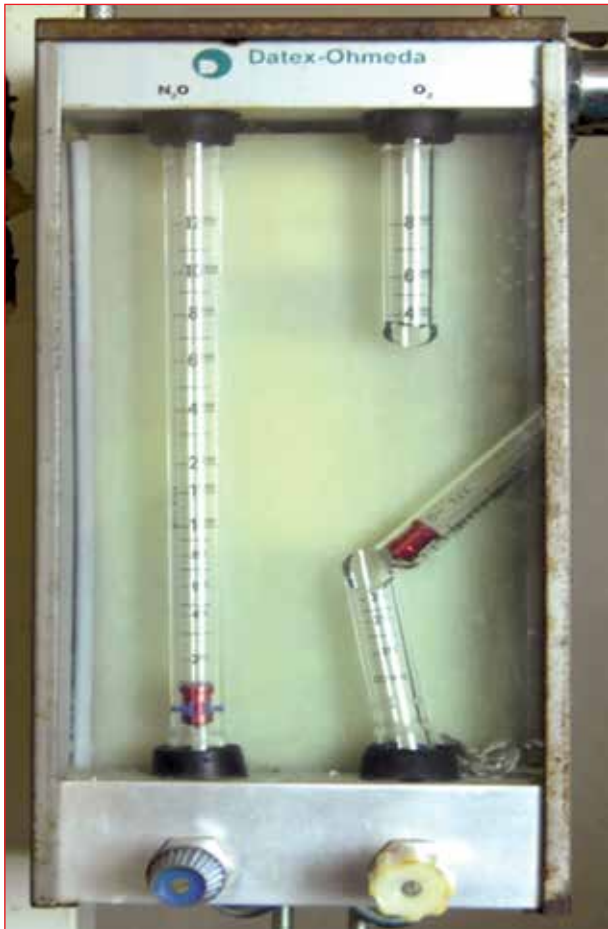
The following day, when the flowmeter was removed by the service engineer, dust particles and dirt were found inside the broken tube. The pressure regulator of the machine and the pressure-reducing valves of the central manifold were found to be undamaged. The stopper at the top of the oxygen flowmeter and the pressure pop-off valve were also found to be normal.

Figure 1: The broken oxygen flowmeter

Accidents never occur because of a single factor, but rather when there is a complex interplay of many influences. We postulate that increased pressure in the pipeline of more than 60 psig (because of lesser demand and transient nonfunctioning of the machine regulator and the pressure-release valve owing to dust and dirt), as well as the fully open oxygen needle valve (in the absence of a second-stage regulator and flow restrictor), caused breakage of the oxygen flowmeter (Figure 1).

Because dirt and dust were found inside the broken flowmeter, it is possible that some of dirt might have settled in the valve seat and diaphragm of the pressure regulator of the machine. This might have caused a steady build-up of pressure in the apparatus.³

One possible cause of the accident is that the high pressure that had developed was transmitted directly to the flowmeter (in the absence of a second-stage regulator and flow restrictor in the machine). The needle valve was almost fully open because of constant adjustment for the flow of oxygen. The sudden surge of high-pressure oxygen could have caused the breakage. The pressure-release valve might not have been working properly at that moment. Another possibility is that there was an existing crack in the flowmeter. The sudden increase in the pressure might have opened it up.

The stopper at the top of the flowmeter was found to be intact. If it had been broken, the bobbin might have partially blocked the exit of oxygen, leading to a pressure build-up in the flowmeter, which would have caused breakage.
